Hurricane Michael in the Area of Mexico Beach, Florida

Abstract: Category 5 Hurricane Michael made landfall near Mexico Beach, Florida on October 9, 2018, with measured high water marks (HWMs) reaching 7.2 m NAVD88. The town itself received great damage, with many areas destroyed down to the foundations. In this study, we document the storm and its effects on the greater Mexico Beach area: hazard, structural damage, and their relationships. Wave and surge damage was nearly total for low-lying properties, but damage decreased greatly with increasing elevation. Major wave and surge damage was noted in Federal Emergency Management Agency (FEMA) X zones, which are out of the 100-year floodplain, and it is suggested that the 100-year storm is a deficient measure for categorizing flood risk. DOI: 10.1061/(ASCE)WW.1943-5460.0000590. This work is made available under the terms of the Creative Commons Attribution 4.0 International license, <https://creativecommons.org/licenses/by/4.0/>.

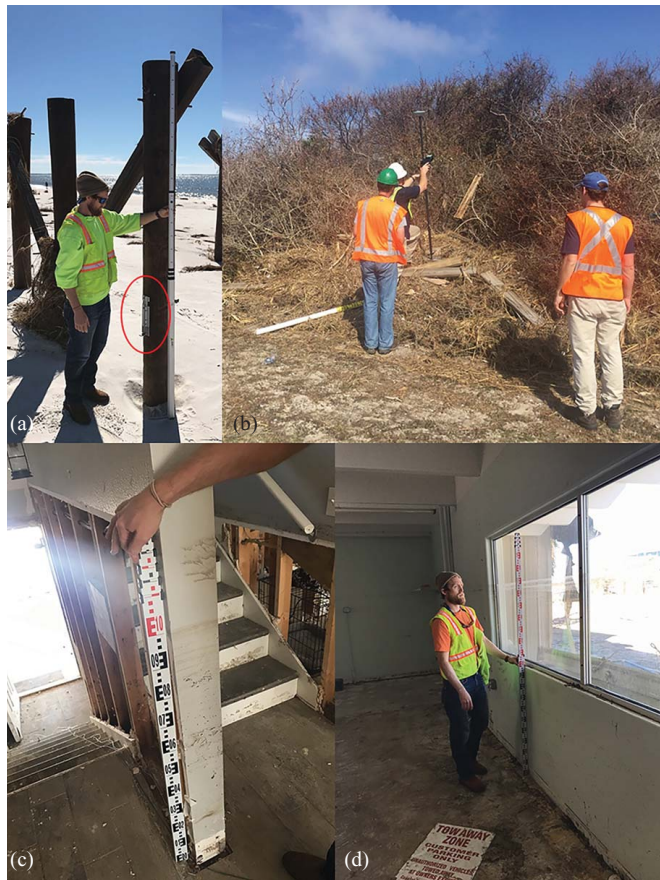
rapid gauge FLBAY03283, which was mounted on one of the pilings on the Mexico Beach Pier (Byrne 2019). The deck and almost all of the pilings seaward of the gauge were destroyed, but the gauge itself survived and provided good measurements. Fig. 2 shows a time series of the instantaneous water levels (computed using the hydrostatic assumption, and with atmospheric pressure, corrections using a nearby noninundated pressure gauge) measured every 30 s on October 10, and a 15 min average of these water levels which will be taken as the surge elevation. Fig. 3 shows the overall gauge location in Mexico Beach, and Fig. 4(a) shows a photograph of the gauge location poststorm.

Fig. 4. (Color) Examples of water level measurements: (a) location of USGS water level gauge at the Mexico Beach Pier, with bracket location circled; (b) highest wave runup location; and (c and d) examples of interior watermarks. (Images by authors.)

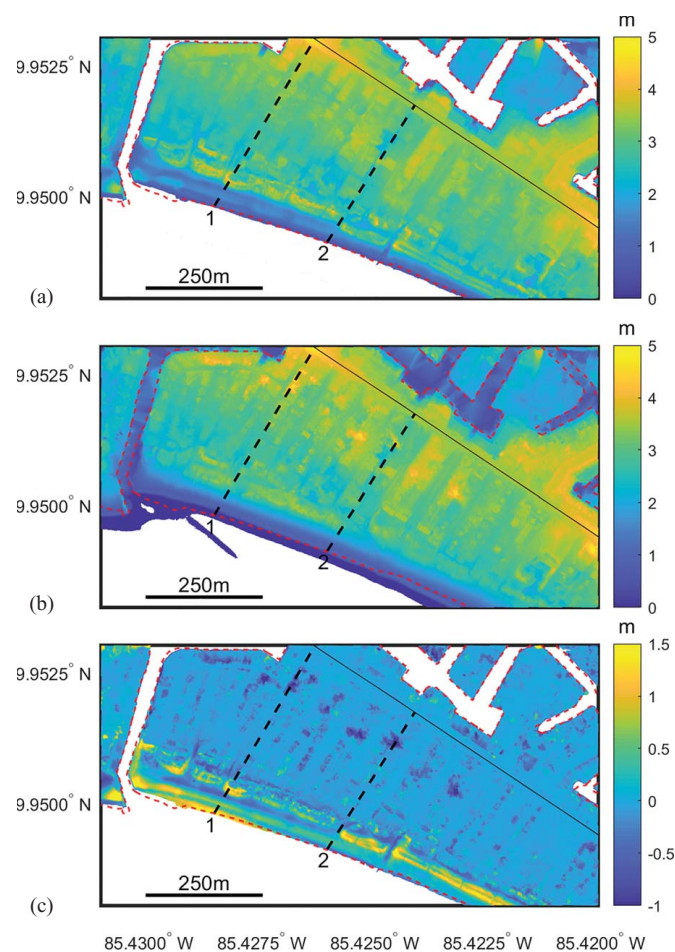
Fig. 5 shows a small but typical section of the beach and the erosion that occurred during Michael. Poststorm (October–November 2018, US Army Corps of Engineers) and prestorm lidar (April–May 2017, Northwest Florida Water Management District) are used to create a difference map, with positive numbers showing the locations of erosion. Both datasets have standard errors listed as 10 cm, which are much lower than the differences seen pre to poststorm. Apart from Michael, there were no major storms in the region in between survey periods.

The major difference in prestorm and poststorm onshore data arises from the complete erosion of the coastal dune system, with up to several meters of elevation loss. Areas of deposition are seen landward in some locations and represent debris piles generated from more seaward houses and other moveable objects. Fig. 6 shows the two transects identified in Fig. 5 before and

Fig. 5. (Color) Erosion example showing elevations in NAVD88 datum: (a) before; (b) after; and (c) difference. Erosion is shown as positive and deposition as negative. Elevations for transects 1 and 2 are shown in Fig. 6.

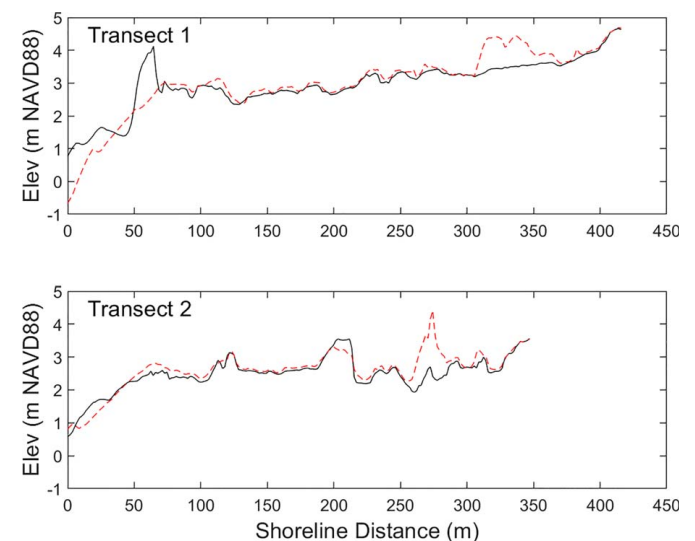
after the storm, which demonstrates the dune erosion. The dune crest elevations of approximately 4 m in transect 1 might also be compared with the peak surge value of 5.16 m NAVD88 and peak wave crest of 6.28 m NAVD88 measured at the nearby pier. These measured water levels greatly exceed the dune crest elevations, placing the system well into the inundation regime (Sallenger 2000) where sediment transport increases significantly and heavy dune erosion is expected. Once dune erosion was complete, large waves would have been able to penetrate inland with relatively little to impede them before encountering the many structures located close to the shoreline. Transect 2 provides a second example with no large fronting dunes, showing little overall erosion or accretion in the immediate beachfront area. However, both transects were chosen to intersect large debris piles, which were found in many undated locations and will be assessed in more detail in the following sections. These debris piles showed large increases in elevation to the tops of debris, however, actual ground elevations underneath the debris had little to no erosion or accretion.

Fig. 6. (Color) Before storm (-) and poststorm (- -) bare earth elevation transects in NW Mexico Beach from the nominal shoreline to HWY98. Locations for Transects 1–2 are shown in Fig. 5.

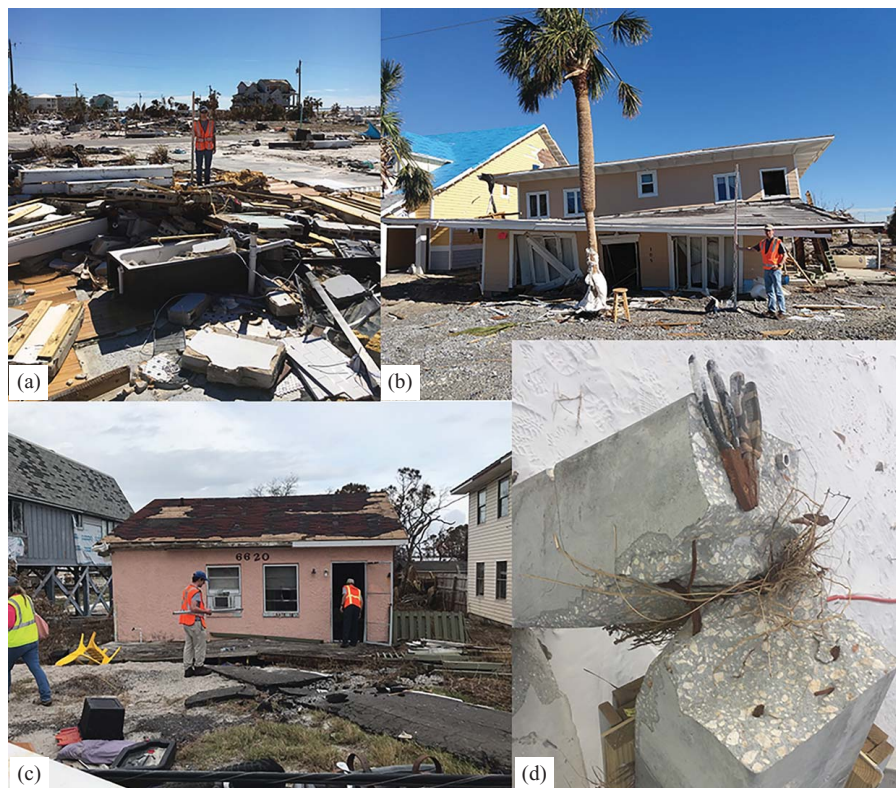
included the destruction of the entire structural frame (7a), structures detaching from foundations either at-grade (7b), or on top of piles (8a), loss of roof cover (7c), piled foundation loss of capacity or breakage (7d, 8a), wave damage to exposed structural components (8b), and erosional failures of foundations and associated components (8d). Observed structural failures are typical of a large wave and surge event (Robertson et al. 2007; Tajima et al. 2014; Tomiczek et al. 2014; Hatzikyriakou et al. 2016) where inundation depths are large and waves can generate destructive loading on exposed structures.

Fig. 7. (Color) Examples of structural damage: (a) destruction of at-grade house (DS6); (b) at-grade house detached from its foundations by waves and surge (DS6); (c) damaged at-grade house (note sheets of asphalt detached from road) (DS3); and (d) failure of prestressed concrete piling (DS6). (Images by authors.)

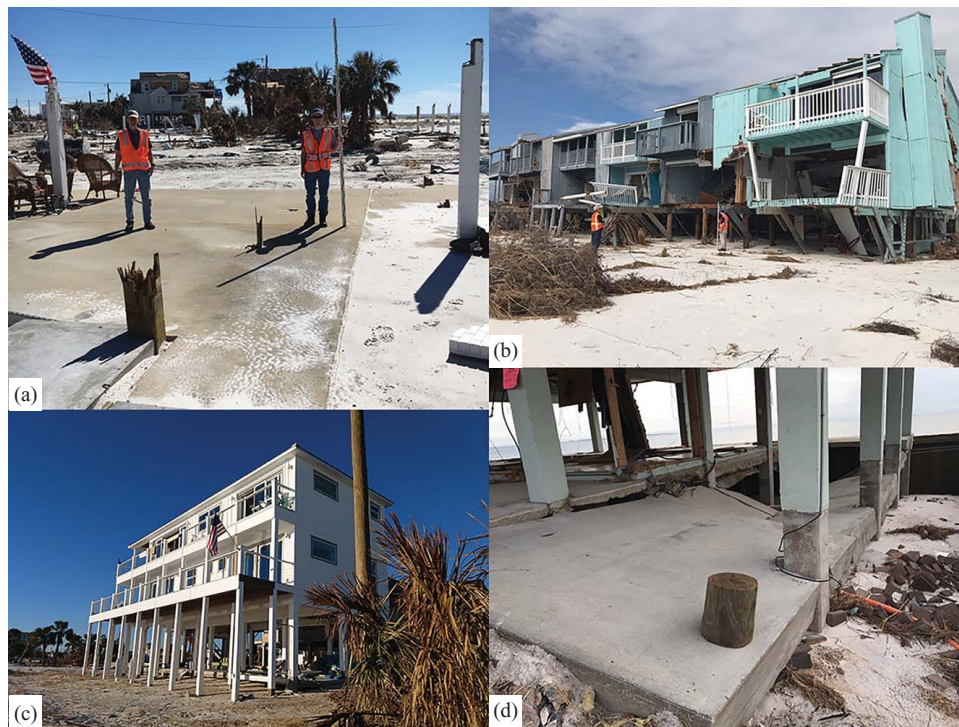
Near to the shoreline, the only structures that did not experience major damage were well built elevated structures, and even these generally lost utility connections and often staircases [e.g., Fig. 8(c)], and were prone to interior water damage from loss of soffits and damaged fenestration. Figs. 7 and 8 show examples of damage observed in the Mexico Beach area. Failure modes

Fig. 8. (Color) Examples of structural damage: (a) complete failure of pile elevated house (DS6); (b) severe damage to beachfront pile elevated row houses (DS5); (c) minor damage to Sand Palace (DS3); and (d) scour and partial failure of concrete floor pad underneath pile elevated house (DS5). (Images by authors.)

There were examples of good design and practice, the most impressive structural survival was the famous Sand Palace house built in 2018 and shown in Fig. 8(c). Although it is in the first row of houses near the region of worst surge and damage, the Sand Palace only had damage to: (1) utilities and local HVAC destroyed; (2) exterior staircase and lower story breakaway walls and interior destroyed; (3) a cracked window on the top floor; (4) one electrical outlet on the top floor ceiling popped out of its socket due to the pressure difference between the house interior and attic; (5) damage to parking slab and pavers; (6) minor water intrusion; and (7) one porch ceiling damaged. No roof damage was recorded. By the time of the team’s visit, the owners had installed solar panels and batteries to provide electricity and except for town utilities were fully functional. The Sand Palace was in DFIRM Zone AE, elevation 12 ft (3.66 m) NAVD88, while the measured elevation of the LHM was 6.3 m (20.7 ft) NAVD88. This elevation almost exactly matched the largest measured wave elevation of 6.28 m NAVD88 measured at the nearby pier. Because the pier was slightly seaward of the Sand Palace, wave crest elevations at the house would likely have been slightly lower. Therefore, the largest wave crests during the storm came close to or barely touched, the LHM, and wave loads were certainly much lower than those experienced by houses at a lower elevation. As reported, the Sand Palace costs approximately 15%–20% additional per square foot when compared with standard construction practices (Dal Pino 2019). After Michael, and compared with its neighbors, this additional cost appears very well spent. This study also demonstrates that community

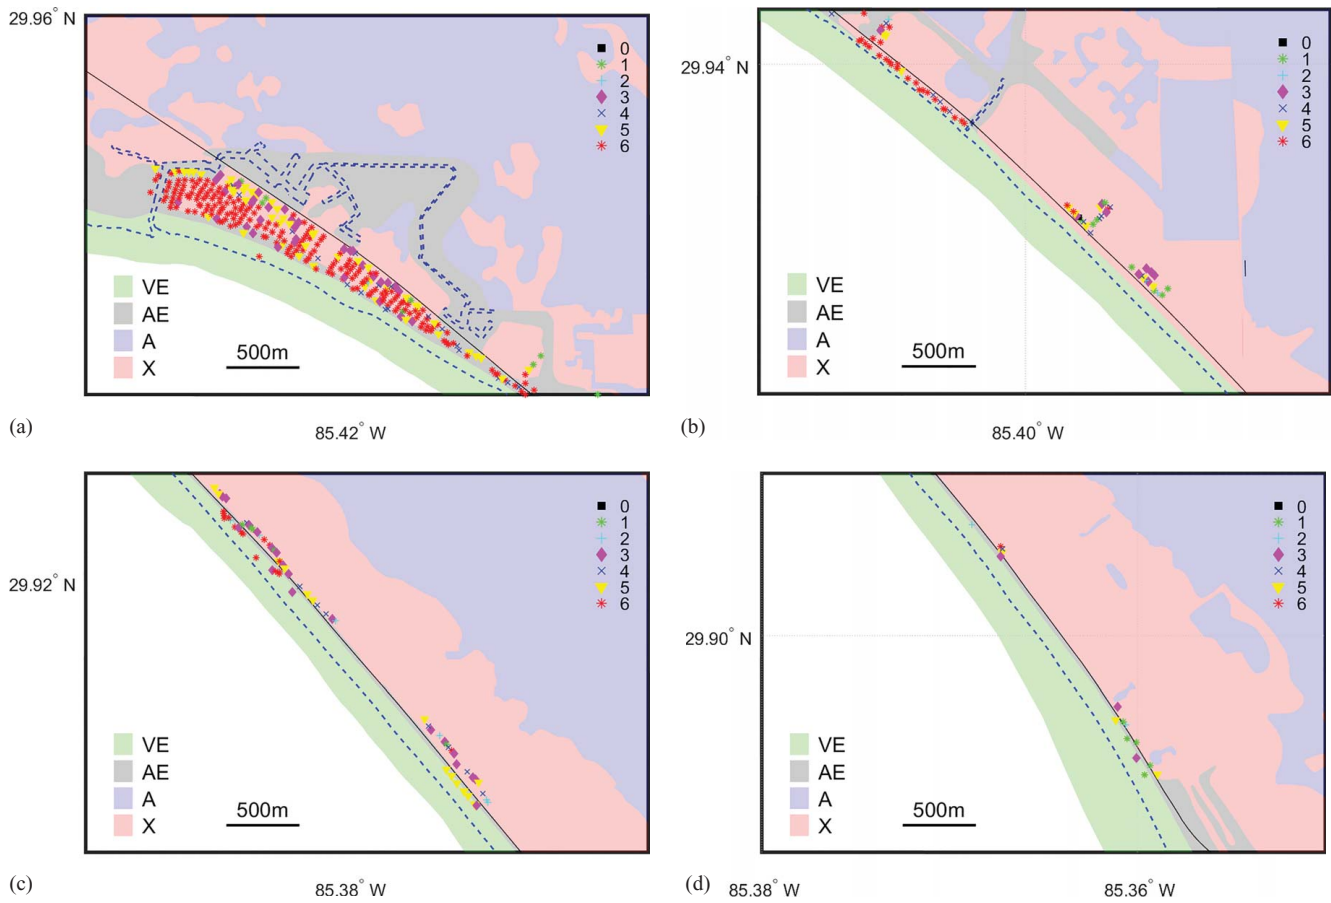
Fig. 10 shows the overall surge and wave induced damage ratings for all structures surveyed by the team in the Mexico Beach area, divided into the four subregions shown in Fig. 9. It is clear that in area (a) (furthest NW), large areas near the shoreline suffered complete damage, while the furthest SE section (d) showed areas near the shoreline with damage, but not anywhere near the extent of (a), with (b–c) demonstrating intermediate levels of damage.

Fig. 10. (Color) Surge and wave induced structural damage states as in Tomiczek et al. (2017). Black square = DS0; green diamond = DS1; cyan + = DS2; magenta diamond = DS3; blue x = DS4; yellow triangle = DS5; red * = DS6: (a) subregion a; (b) subregion b; (c) subregion c; and (d) subregion d. FEMA DFIRM flood zones are as labeled.

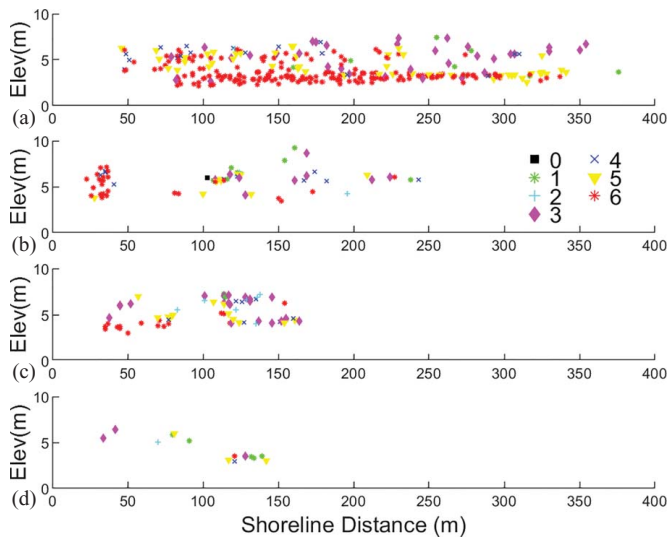
The damage state was found to be a strong function of structural elevation as shown in Fig. 11, in particular, close to the shoreline. This is not at all surprising, because structures at higher elevations may encounter waves and surge for a shorter length of time, or not at all if they are sufficiently elevated. Structures built at-grade were almost universally destroyed in the most severe conditions near the shoreline (DS6) and were largely older single family houses. Structures at higher elevations demonstrated much higher survivability,

Fig. 11. (Color) Damage state versus elevation of LHMs in m NAVD88, and distance from shoreline in the subregions (a–d) as shown in Fig. 9.

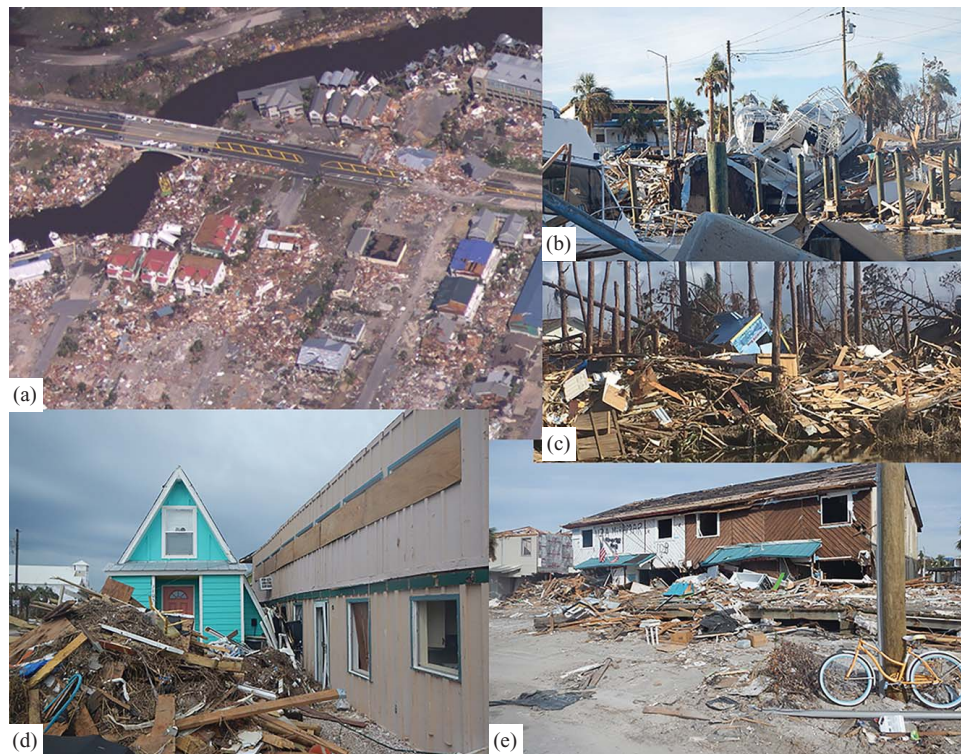
The destruction of structures and infrastructure generated large amounts of debris, much of which was transported inland. Fig. 14 shows typical examples of debris and debris piles. These could be quite large at times for both plan area and height above ground, as shown in the transects in Fig. 6. On a large scale, this debris was composed of entire structures detached from their

Fig. 14. (Color) Examples of debris transport and deposition: (a) Western Mexico Beach (image courtesy of NOAA), showing large debris piles; (b) boats and terrestrial debris; (c) waverunner rental shack and other debris in forested area; (d) large pile of woody debris and transported A-frame house grounded next to larger building; and (e) 34 m-long section of Mexico Beach Pier deck grounded against houses. (Images (b–e) by authors.)
