Field Survey and Numerical Modelling of the December 22, 2018 Anak Krakatau Tsunami

Abstract—On December 22, 2018, the eruption and flank collapse of the Anak Krakatau volcano generated a tsunami in the Sunda Strait causing catastrophic damage to uninhabited coastlines proximal to the source. Along the heavily populated shores of Banten and Lampung provinces in Java and Sumatra, tsunami waves caused severe damage, extensive inundation and more than 430 deaths. An international tsunami survey team (ITST) deployed 6 weeks after the event documented the tsunami effects including runup heights, flow depths and inundation distances, as well as sediment deposition patterns and impacts on infrastructure and the natural environment. The team also interviewed numerous eyewitnesses and educated residents about tsunami hazards. This ITST was the first to visit and document the extreme tsunami effects on the small islands in the Sunda Strait closest to Anak Krakatau (Rakata, Panjang, Sertung, Sebesi and Panaitan). Along the steep slopes of Rakata and Sertung islands, located less than 5 km from and facing directly towards the southwest flank of Anak Krakatau,

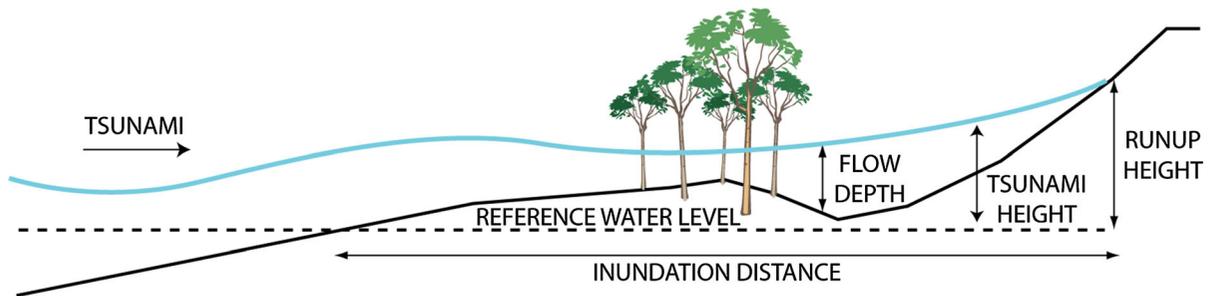
Figure 2
Definition sketch for flow parameters measured during the field survey

At each site, measurements and interviews were collected using established protocols (i.e. UNESCO 2014). Runup heights, inundation distances and flow depths are defined in Fig. 2. Measurements were taken using a laser rangefinder and a Trimble GPS with differential correction. Given the nature of the boat survey and the distance to the permanent base station on Java of 100–200 km, the elevations were referenced to the sea level and de-tided for the time of

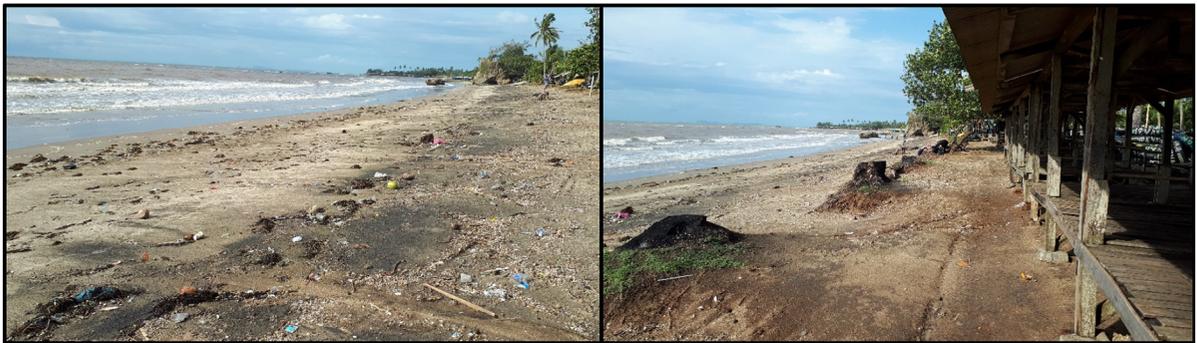
Figure 3
Pasauran Beach, Anyer, 24 December 2018. Vendor stalls are still intact suggesting relatively benign tsunami impacts

At Anyer, several interviews conducted with local workers suggested that the tsunami effects consisted of a rise in the water level of up to 2 m, with inundation less than 10 m from the coastline. Damage in this area was not significant, as lightly constructed vendor stalls made of bamboo remained intact and standing (Fig. 3).

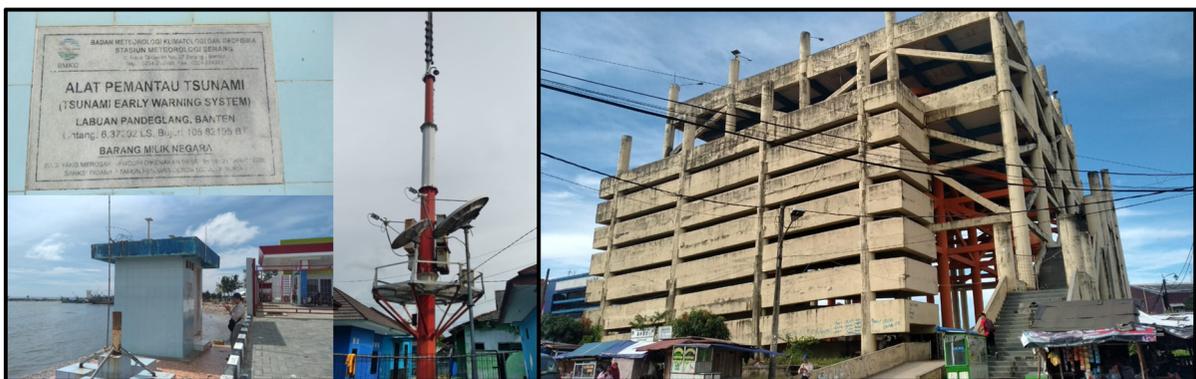
Figure 4
Tsunami warning infrastructure (left) and a vertical evacuation structure (right) in Labuhan

Tsunami monitoring equipment installed at Labuhan in 2012 by BMKG (Indonesia’s Meteorological, Climatological and Geophysical Agency) and a tide gauge for tsunami monitoring were spotted, however both pieces of equipment appeared to be abandoned

A multi-story vertical evacuation structure had been built in Labuhan, as shown in Fig. 4, however it appears abandoned and not well maintained and most of the residents seemed confused when asked about the function of this building.

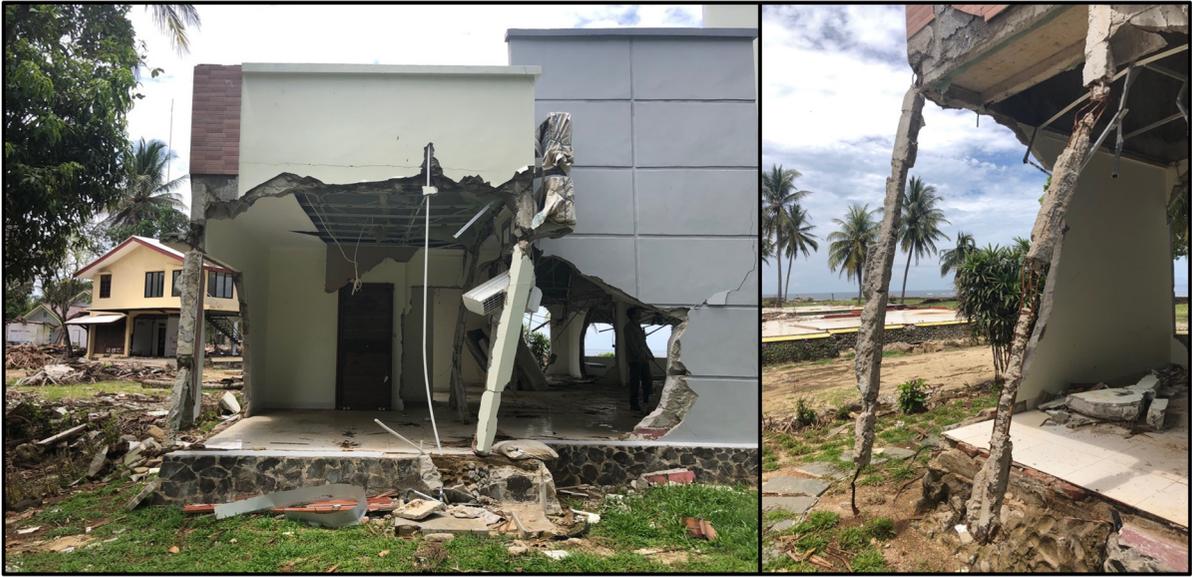
Figure 5
Damage at Mutiara Carita Beach

There was significant tsunami damage at Mutiara Beach where a beachside hotel was heavily impacted. There were reports of 70 casualties, most of them visitors. The damage here was severe with many buildings exhibiting classic tsunami damage where lower story walls were blown out in the direction of the flow (Fig. 5).

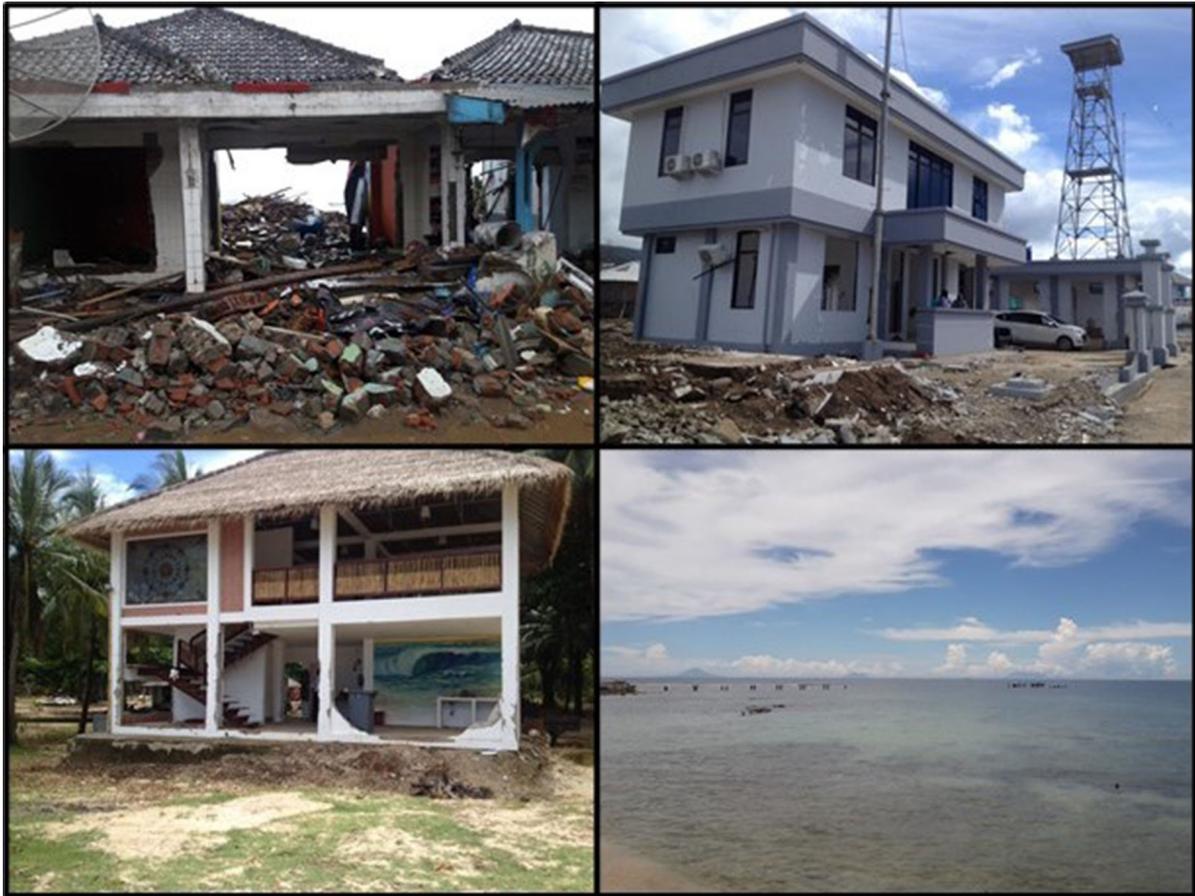
Figure 6

(top row) Damage at Sumur. (bottom row) Damage at Tanjung Lesung Peninsula showing a damaged beach club building and the destroyed wharf

reported larger than the first, while third was about the same as the second. However, when the third wave came, people were already running to escape to higher ground. Tsunami runup was 5–6 m with maximum inundation distances of approximately 200 m. Damage was severe with most buildings destroyed including relatively sturdy brick and cement structures (Fig. 6).

The beach club at Bodur Beach suffered considerable damage with most buildings damaged or destroyed. A wharf used for boat embarkation was also destroyed (Fig. 6). Witness accounts indicated three waves, a smaller first wave was followed by larger and more destructive second and third waves. Tsunami runup was 3–4 m with inundation distances of 150–200 m. This was indicated by damaged buildings and trees with most of the damage concentrated in the first 50 m from the shoreline.

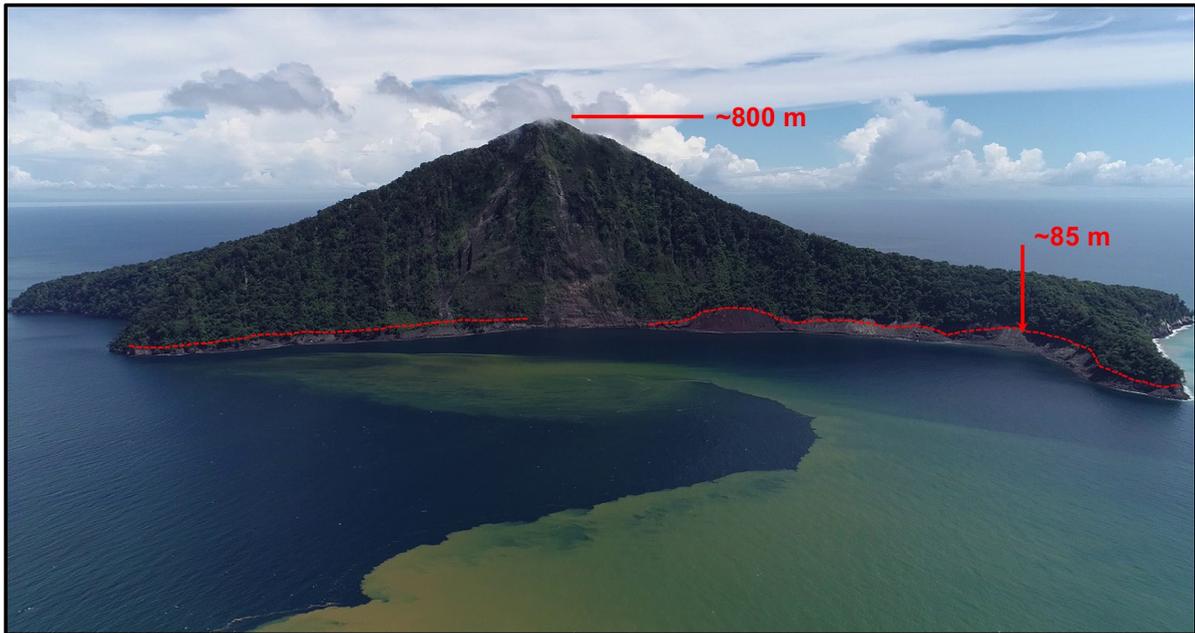
Figure 7

Rakata Island. The tsunami trim line is shown in dashed red and the location of the high runup point of ~ 85 m is indicated. See Fig. 1 inset for location relative to Anak Krakatau

Starting on Rakata, the team first landed on the eastern coast in a cove somewhat protected and facing away from the tsunami source area. Here the team measured runup and tsunami heights of 6–10 m. Moving to the larger, northwest facing embayment revealed a clear tsunami trim line extending across the entire length of the embayment (Fig. 7). Measured tsunami heights increased from east to west starting at over 10 m and increasing to 85 m before dropping off again to ~ 50 m at the northwestern tip of Rakata. Circling the island by boat, the team measured runup heights generally between 4 and 12 m on the shorelines facing away from Anak Krakatau, with the notable exception of two points of ~ 20 m runup on the southern coast, facing directly away from the tsunami source region. This could possibly be the effect of constructive interference from the tsunami wave fronts wrapping around Rakata and meeting each other on the back side of the island, as observed on Babi Island during the surveys

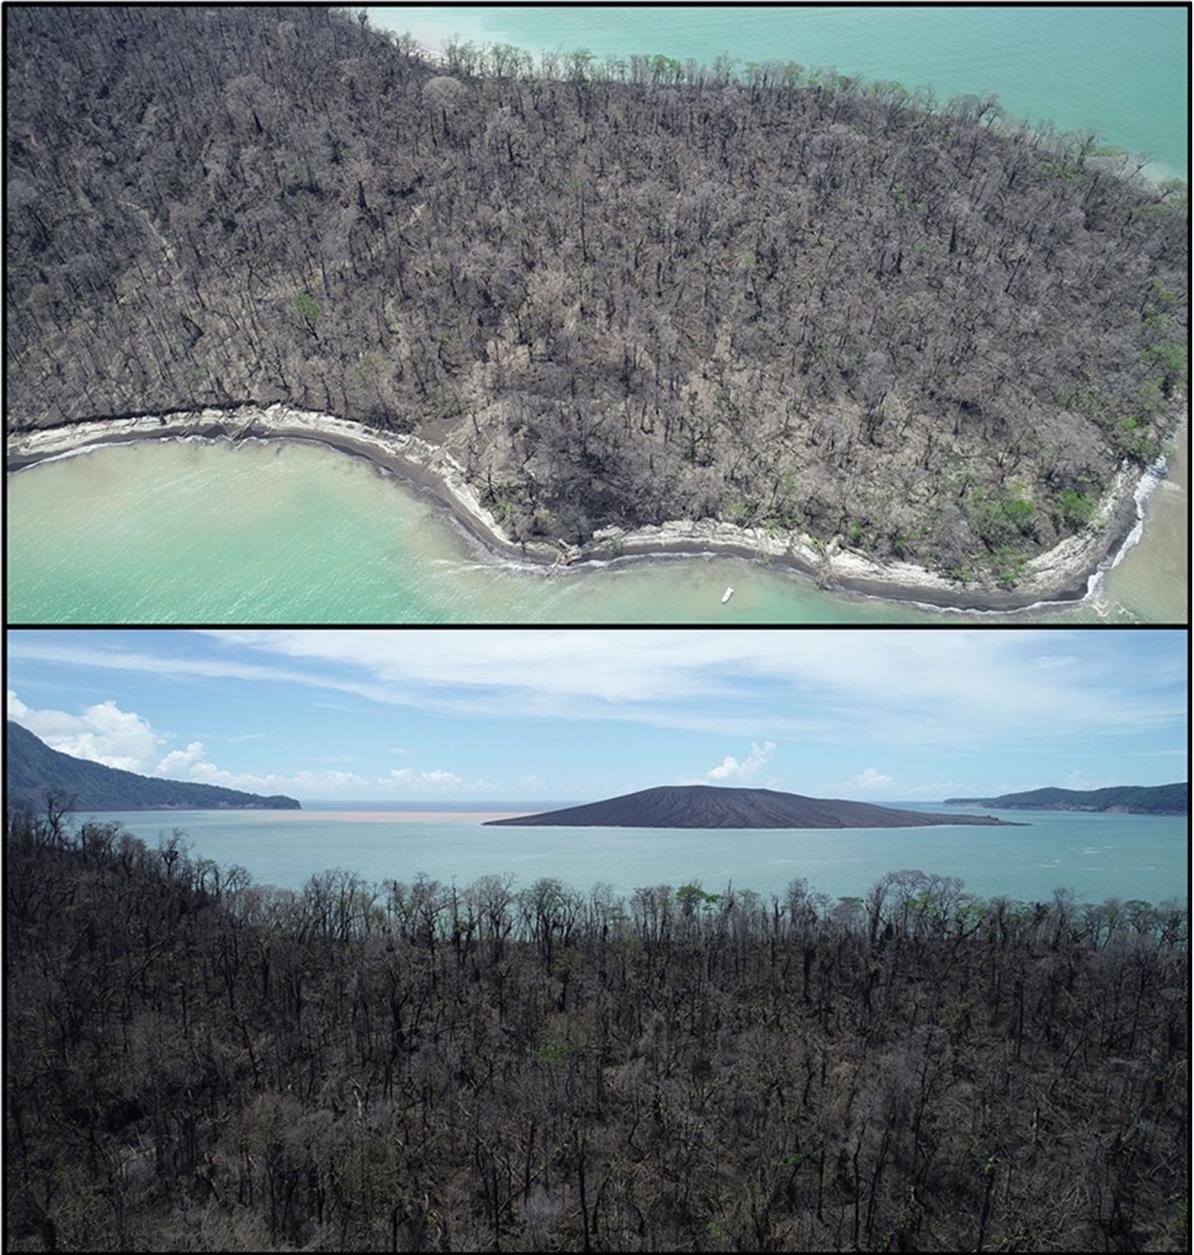
Figure 8

(top) Aerial view of Panjang Island to the north east of Anak Krakatau. Note the dead forest. (bottom) View from above the northern end of Panjang towards the southwest over Anak Krakatau. Sertung to the right and Rakata to the left with the tsunami runup scar/trimline clearly visible. See Fig. 1 inset for relative locations

The team next visited Pulau Panjang (Fig. 8), the island situated to the east of Anak Krakatau. Here a boat landing was only possible on the northern coast where tsunami inundation and runup were measured at 7 to 9 m. The island itself was covered with fresh ash deposits, the trees had lost most of their leaves with only snags remaining and the entire landscape appeared to have been ‘cooked’. We attribute this to the hot ash from the eruption which was blown over the island by the prevailing southwesterly winds for a period of days following the eruptions. Along the western shore of Panjang there was evidence of tsunami runup and small-scale landslides which could have been caused by tsunami uprush.

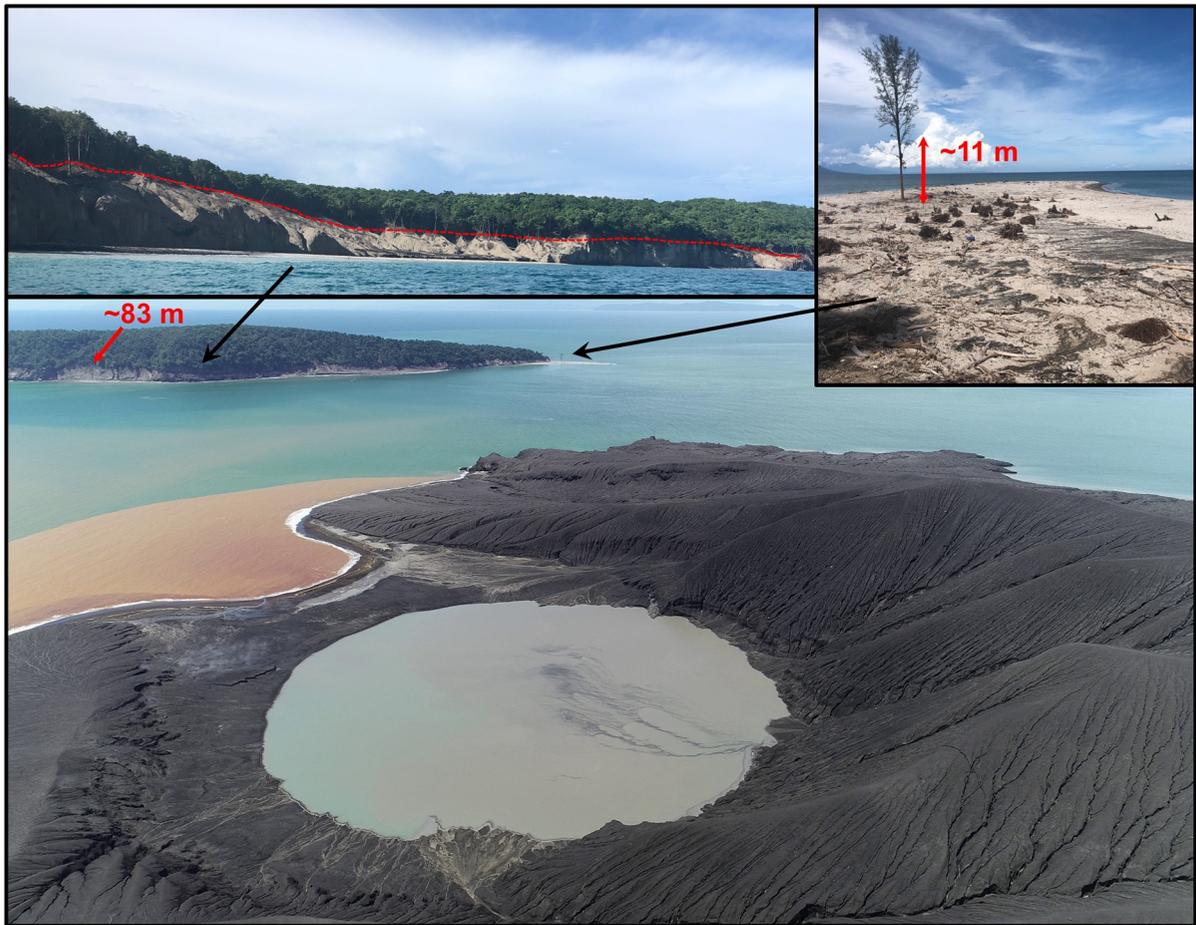
Figure 9

(top right) The lone tree on the northeast tip of Sertung where the tsunami completely over washed the sandspit. (top left) The tsunami trim line is indicated in red. (bottom) The location of the maximum runup height of 83 m as seen from the direction of Anak Krakatau

Along the northwestern tip of Pulau Sertung (Fig. 9), the team measured tsunami runup of 26 m which penetrated about 50 m up a small ravine. The extreme tip of the island was covered with a deep layer of pumice. A stand of trees which had existed there had been sheared off at their base, presumably by the tsunami. A lone standing tree exhibited evidence of tsunami impact and had large chunks of bark stripped off up to heights of > 10 m above ground level and broken branches at 14 m elevation, suggesting this value as a minimum flow depth.

Along the south facing coast of Sertung there was clear evidence of extreme tsunami effects with all the vegetation stripped off the steep coastal bluffs up to an elevation of 83 m in one location. This trim line was relatively consistent across the entire southern

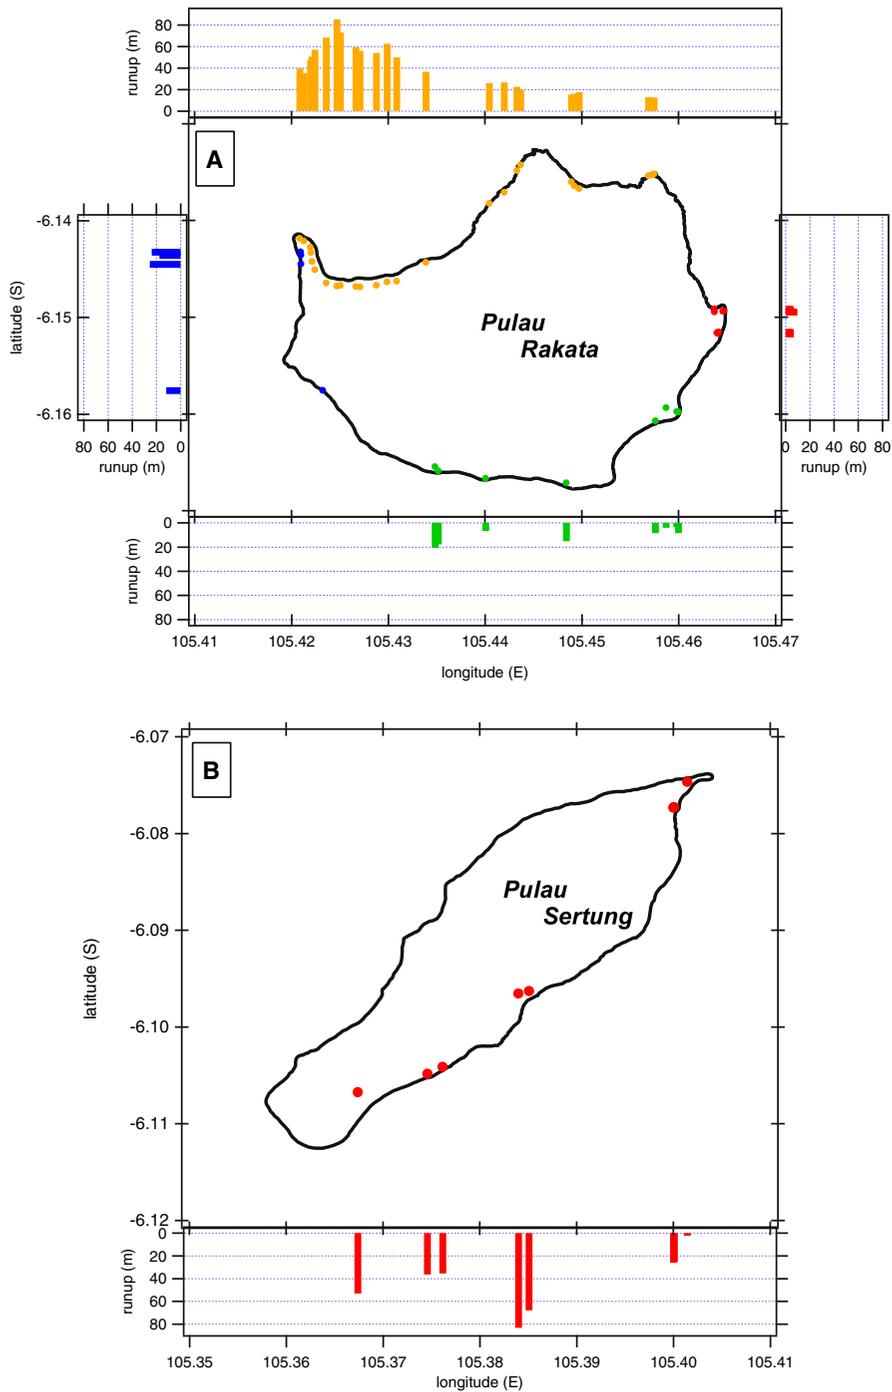
Figure 10
 Measured tsunami heights on Rakata (a) and Sertung (b)

shore of the island. The measured tsunami runup heights from Rakata and Sertung are plotted in Fig. 10.

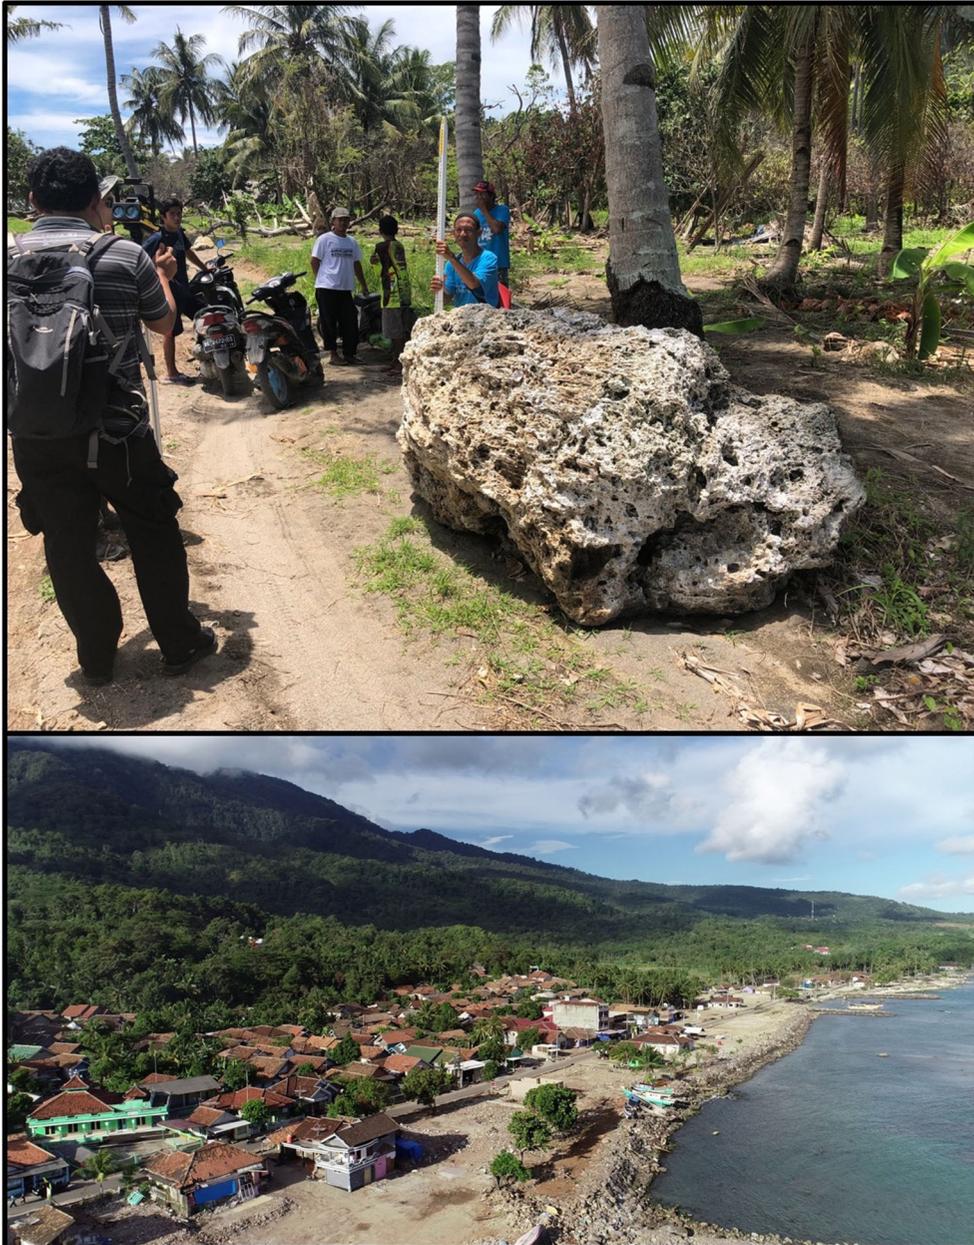
Figure 11

(top) On Sebesi, a large coral boulder displaced from ~ 60 m offshore was transported some 40 m inland. (bottom) The heavily damaged Waymuli water front. Much of the debris had been cleared away by the time of the survey, hence the open areas at the shoreline

arrived at approximately 9:30 PM. As with Sebesi, eyewitnesses reported that the first wave was the largest. Tsunami runup was measured at 4.25 m with inundation of up to 100 m. The damage at Waymuli was severe with a large number of buildings damaged or destroyed between the seafront and the coastal road (see Fig. 11). By the time this survey was conducted, much of the debris had been cleared away.

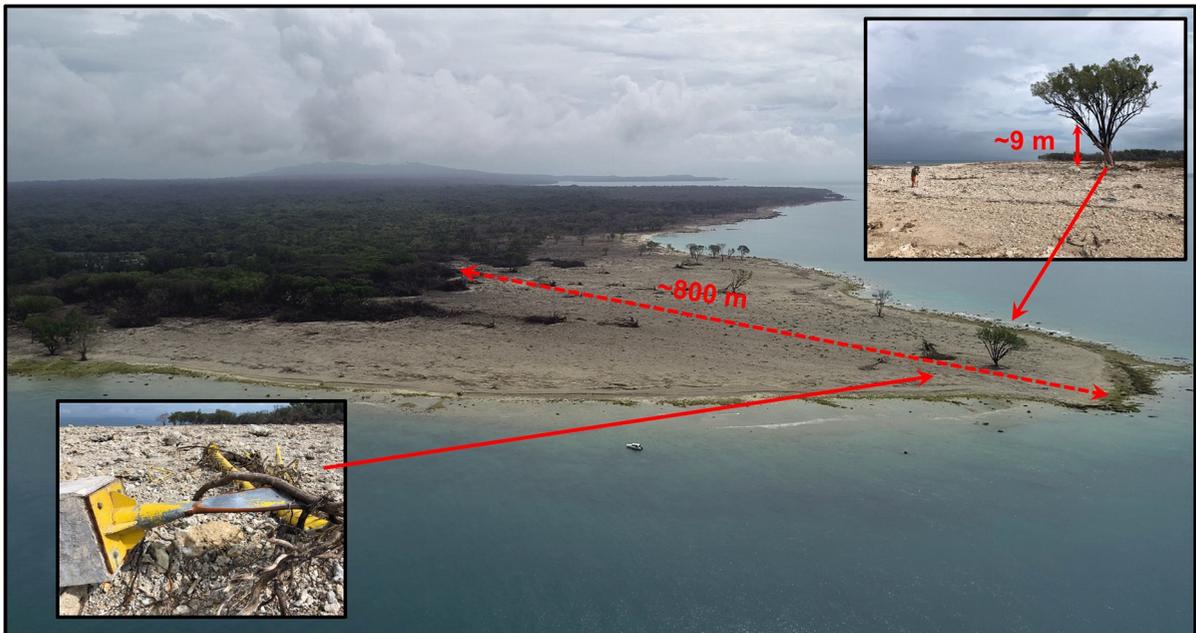
Figure 12

The northern tip of Ujung Kulon. Inset images show the height of flow depth traces left on a lone surviving tree and the location of the twisted remains of a steel navigation light that was previously installed at the shoreline

stripped away leaving behind only coral rubble (Fig. 12).

whereas at the northern tip of Ujung Kulon, flow depths at the shoreline were at least 9.1 m (Fig. 13).

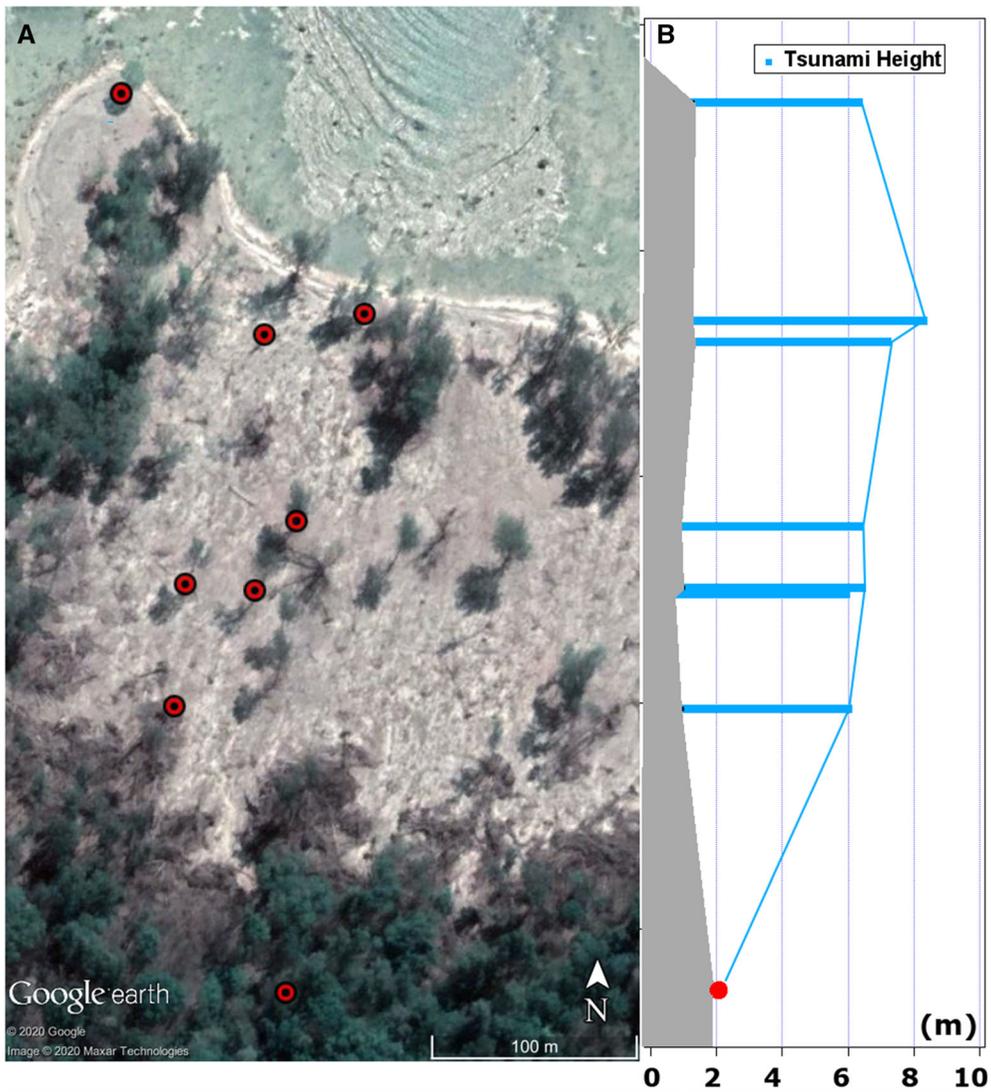
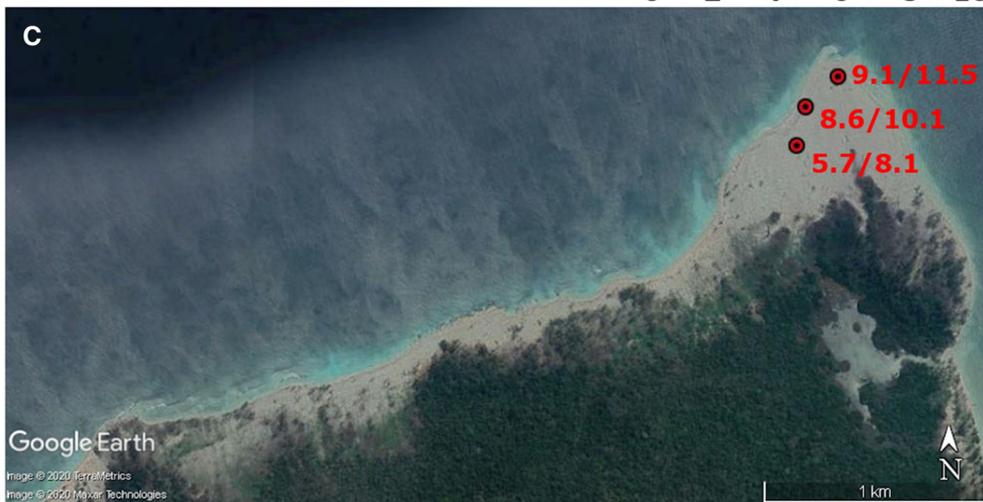
a Locations of measured tsunami runup and flow depths at the northern tip of Panaitan Island. **b** Tsunami height at each point in A indicated with the blue bars over ground level (gray shaded area). Red dot indicates the location of the end of the inundation extent along the transect. **c** Data point locations from the northern tip of Ujung Kulon. Numbers indicate tsunami flow depth over ground and total tsunami height above sea level respectively. The inundation zones at both sites are easily identified by the light colored areas which are bare coral rock. Prior to the tsunami both sites were covered with dense tropical forest to the shoreline

On Panaitan, the ITST measured tsunami flow depths of 5–7 m with inundation of up to 350 m

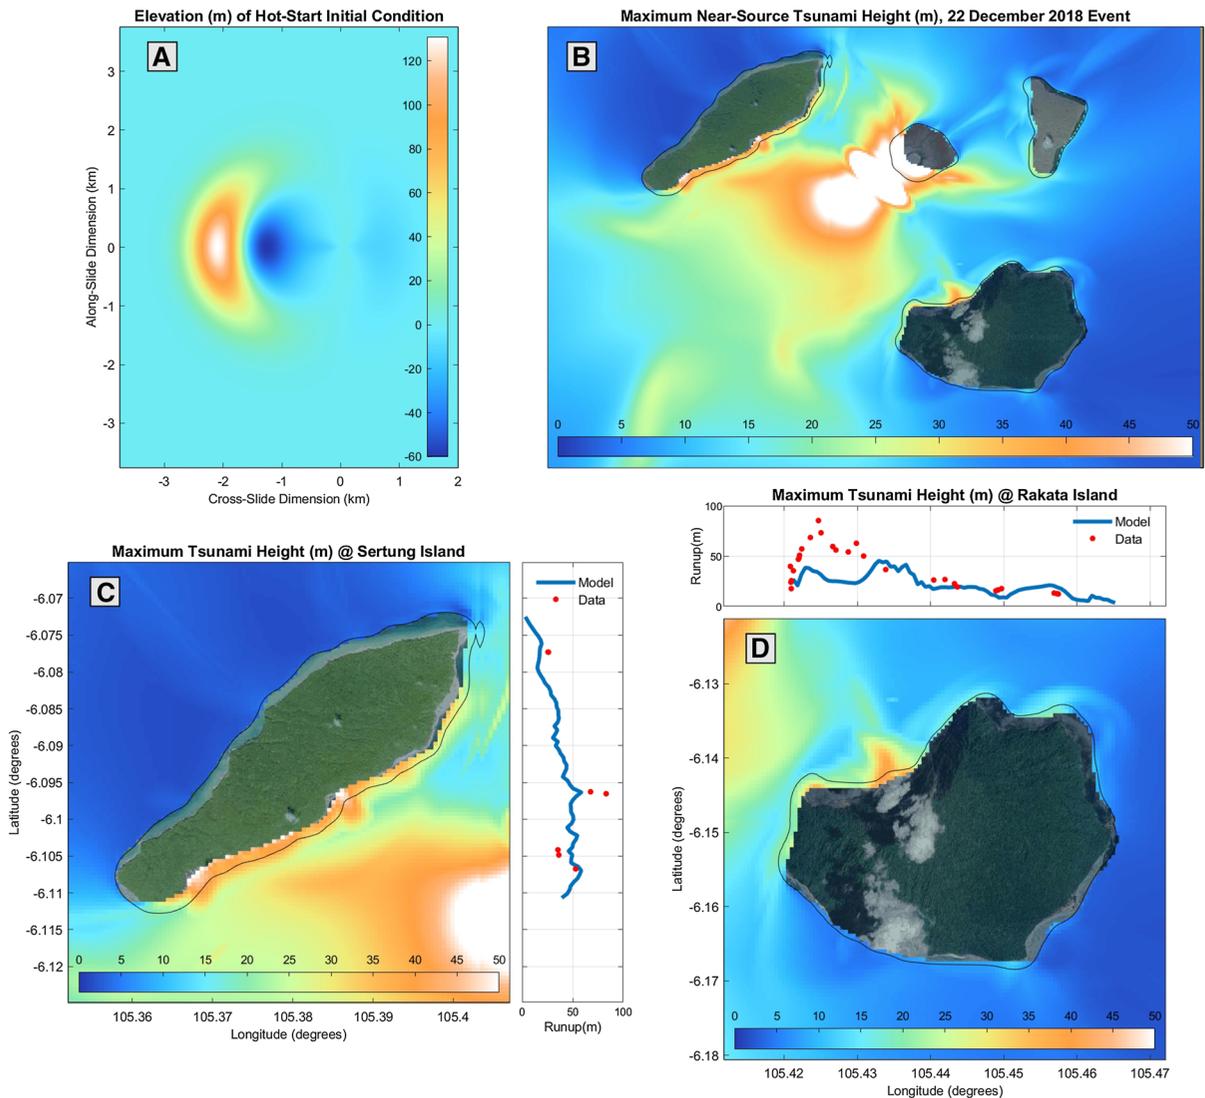
Figure 14

Initial water surface used as a hot-start initial condition in the numerical model (a), and near-field propagation of the tsunami (b–d). Subplot b provides the maximum tsunami amplitude near the source, while c and d are focused on Rakata and Sertung, respectively, and show the numerical-field data runup comparisons

to the observed near field tsunami run up heights was found. Ultimately, the source parameters listed in Table 1 were used to generate the initial tsunami source depicted in (Fig. 14). This solution is used to provide order of magnitude estimates for the generated crest elevation and horizontal length scales and is not meant to capture the complex source dynamics of the Anak Krakatau failure.

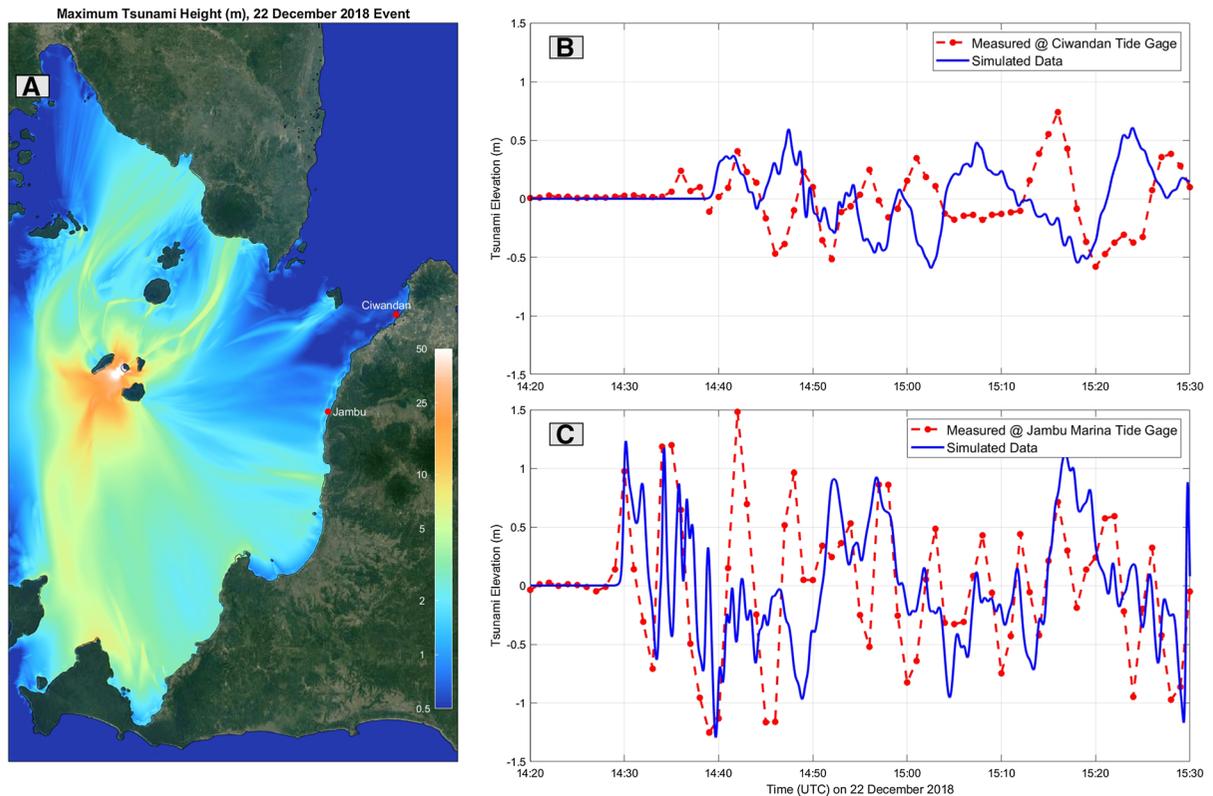
Figure 15

Maximum modelled tsunami heights around the Sunda Strait **a** for the 2018 Anak Krakatau tsunami. Comparison between measured and modelled tsunami heights at Ciwandan (**b**) and Jambu (**c**). In the tide station data (red lines), the red points indicate the measurement sampling rate

The modelling results presented here show an extremely steep and nonlinear wave in the source region with rapidly radial spreading of energy. There is clear directionality of energy to the southwest, indicating that the largest waves in the nearfield did not directly approach any of the coastlines of Rakata, Sertung, and Panjang. As the tsunami propagated away from the source region, frequency dispersion, radial energy spreading, and refraction control the local amplification of the tsunami amplitude. In the far field, the modelling captures the observed areas of focusing to the south (e.g. Ujung Kulon), east (e.g. Bodur Beach), and to the north (e.g. Way Muli). As shown, and as is typical for earthquake tsunami hazard assessments, the precise detail of the source and initial waves, which is disregarded here, is not of leading order importance for far-field predictions.
