Probabilistic Estimates of Tsunami Risk for Small Craft Marinas

Abstract: Since the 2006 Kuril Islands tsunami, California small craft marinas have sustained over \$100 million in total damage from tsunami events. Surveys conducted after the 2006 Kuril Islands and 2011 Japan tsunamis indicated that the mooring systems (e.g., cleats and pile guides) responsible for keeping the vessels and floating docks in place during an event are susceptible to failure. The aim of this paper is to present a risk framework that can be used by decision makers to assess future tsunami risks to small craft marinas. Here, the coupling of high-resolution numerical modeling and an existing statistical framework is extended to include observed damage states for structural elements. When applied to one small craft marina (in Noyo River Harbor), our methodology was able to replicate likely failure, which occurred well below previously identified damage thresholds. The results suggest infrastructure age and condition, in addition to the hazardous tsunami phenomenon, can contribute to cleat and pile guide failure. **DOI:** [10.1061/\(ASCE\)WW.1943-5460.0000599](https://doi.org/10.1061/(ASCE)WW.1943-5460.0000

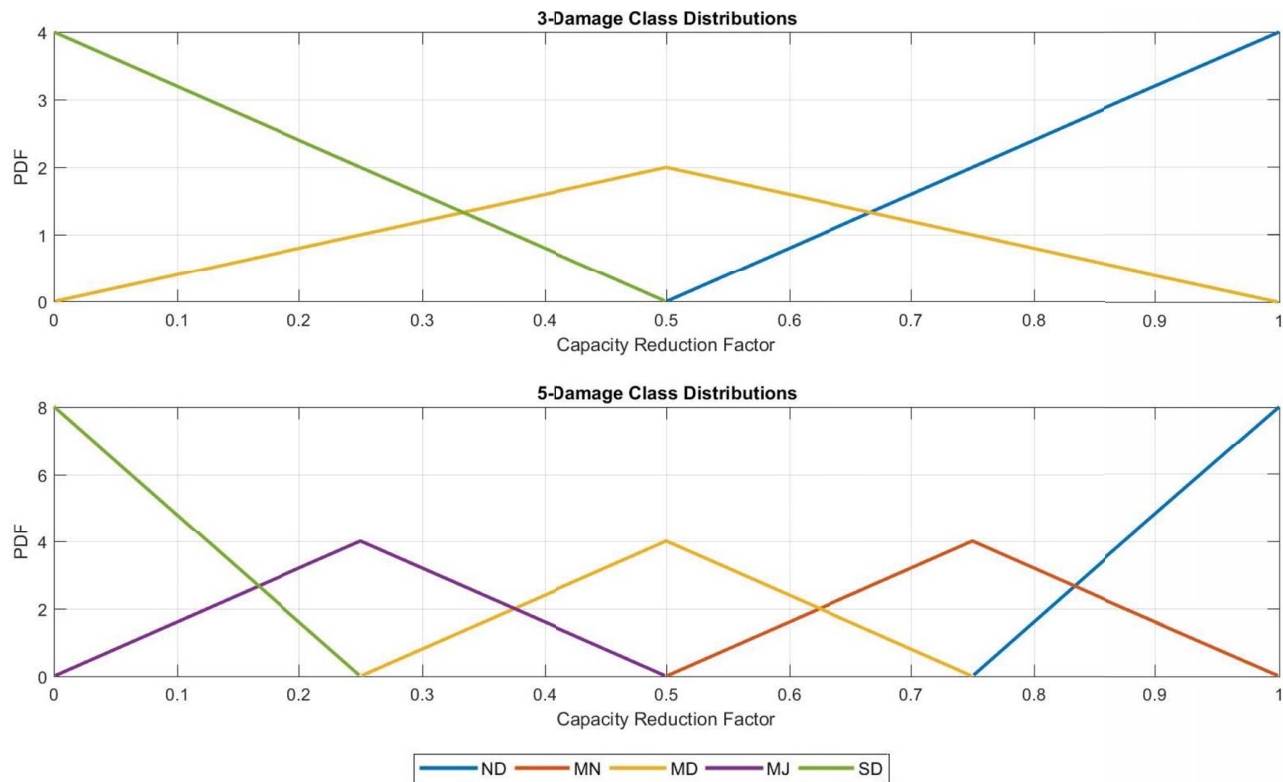
Fig. 2. Capacity reduction factor distributions determined based upon observable degradation. The five damage class distributions are: no damage (ND), minor damage (MN), moderate damage (MD), major damage (MJ) and severe damage (SD) [consistent with the damage states outlined by Waterfront Inspection Task Committee (2015)].

The survey of California harbors and the photo analysis indicated that cleat and pile guide conditions within a harbor largely center around an expected mean with some natural variability. Expert judgment was used to construct a trapezoidal distribution (Fig. 2) for each damage state that allows natural variability in each damage state to be included in the probabilistic model. The five damage class distributions (from Fig. 2) are: no damage (ND), minor damage (MN), moderate damage (MD), major damage (MJ), and severe damage (SD) [consistent with the damage states outlined by Waterfront Inspection Task Committee (2015) and those published in this paper].

class (Damage Class 5) range with corrosion exceeding 75% of the cleat. The cleat capacity range should therefore be between 0 and 35.1 kN (see Fig. 2).

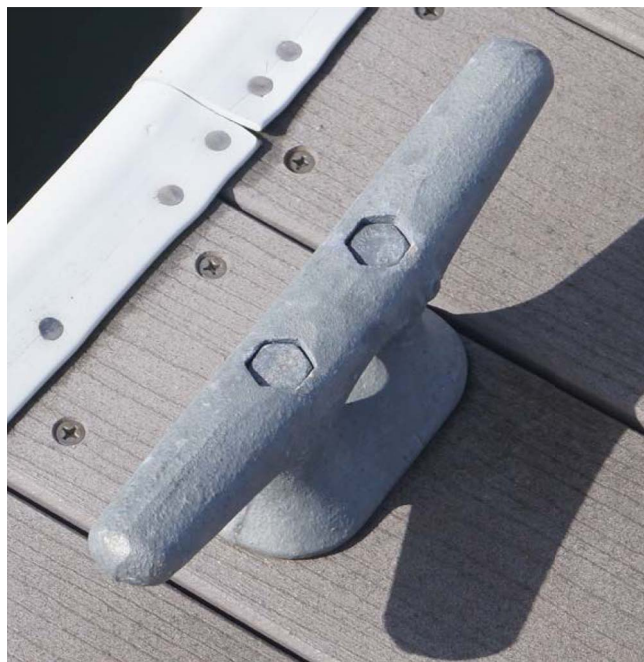
Fig. 3. Typical cleat configuration for California small craft harbors. (Reprinted from Keen et al. 2017, ©ASCE.)

failure modes for this system indicate that heavy corrosion and/or bolt pullout failure are the most common failure modes.

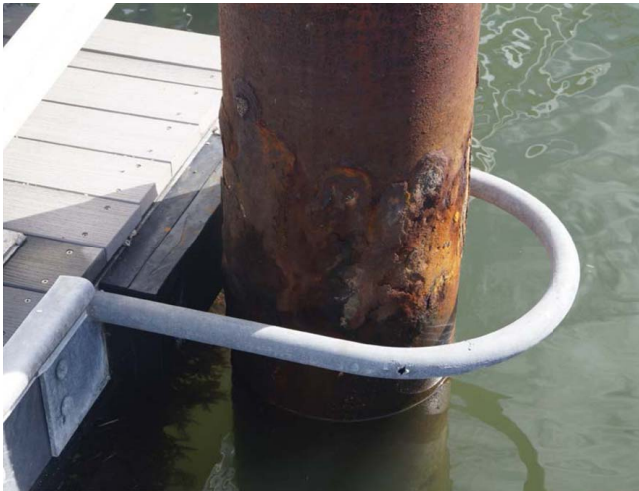
Fig. 4. Typical hoop-type pile guide configuration for California small craft harbors. (Reprinted from Keen et al. 2017, ©ASCE.)

The hoop-type pile guide is one of three types identified during the field survey, commonly used in harbors that support their floating docks with round piles. A sample of this style of hoop-type pile guide is shown in Fig. 4. This type of pile guide consists of a section of metal pipe curved into a C-shape that wraps around the pile. The hoop is then connected to the dock by a metal bracket bolted through the whalers with either two or four bolts. The two metal segments are either welded or bolted together. Like the cleats,

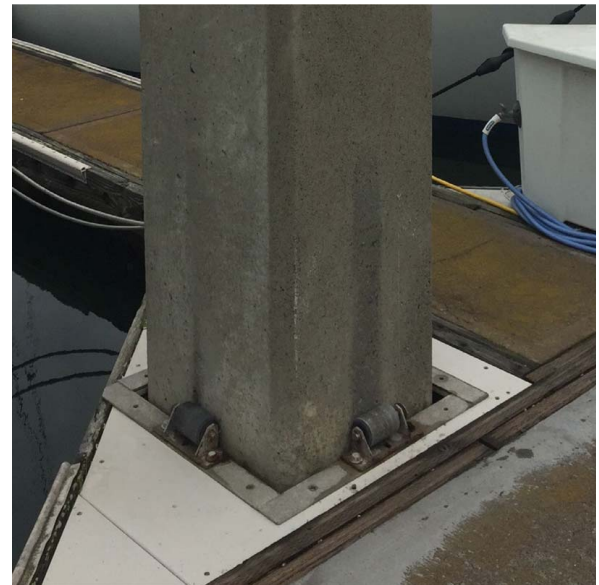
Fig. 5. Typical roller-type pile guide configuration for California small craft harbors. (Image by Adam S. Keen.)

where τ_{bolt} = bolt shear capacity. The form of this equation is consistent with the expected failure mode (shear failure) with the added term α representative of the pile guide's aging and decreased capacity with increased design life.

Observed damage states for hoop-type pile guides are presented Table 3. Much like cleat and hoop-type pile guide failure, the damage states for roller-type pile guides closely relate the amount of corrosion and pitting to the remaining capacity of the pile guide. However, for roller-type pile guides, we only defined three typical damage states

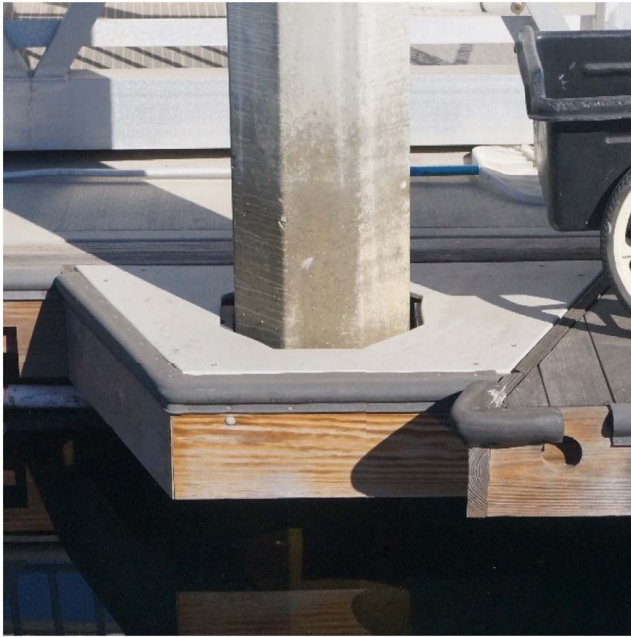
Fig. 6. Typical high-density polyethylene (HDPE) pile guide configuration for California small craft harbors. (Image by Adam S. Keen.)

an HDPE pile guide is shown in Fig. 6. This type of pile guide represents a technology advancement, and is ordinarily found in newly built harbors or harbors that experienced damage from the 2010 Chile or the 2011 Tōhoku tsunamis. For instance, Crescent City Harbor, which was nearly destroyed in the 2011 Tōhoku tsunami, replaced all the pile guides in the harbor with HDPE pile guides.

One advantage of HDPE pile guides is that they are nearly maintenance free. The pile guides are not vulnerable to corrosion like hoop-type pile guides, nor do they require regular servicing like a roller-type pile guide. However, since HDPE pile guides represent newly built construction, developing an understanding of the failure modes and aging process is not currently possible. Therefore, we used the model of the roller-type pile guide, assuming that the reduction in the coefficient of static friction between

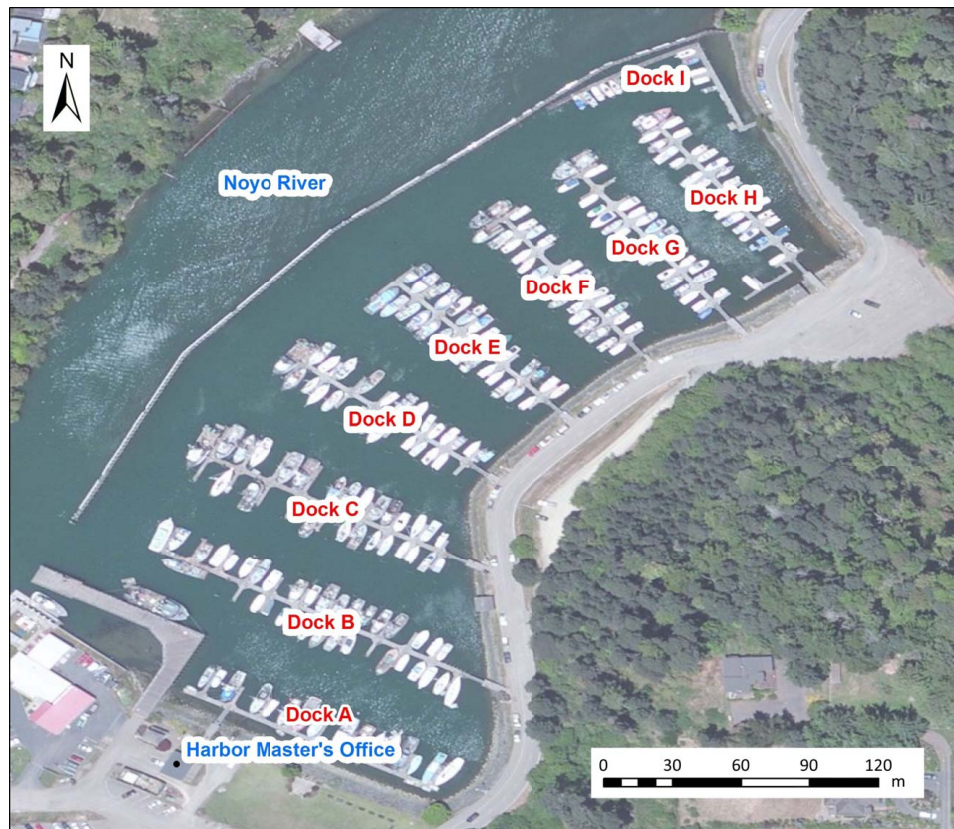
Fig. 7. Location of floating docks in Noyo Basin. (Aerial imagery courtesy of USGS.)

Noyo Harbor District is a small port located along the Northern California Coast (see Fig. 1). The harbor is built near the mouth of the Noyo River in the town of Noyo, just south of Fort Bragg, California. Noyo Harbor consists of two basins. Noyo Basin is the largest of the two and harbors mostly commercial vessels. A map of Noyo Basin is shown in Fig. 7. Dolphin Basin, upriver from Noyo Basin, is the smaller of the two and harbors mostly recreational vessels; Dolphin Basin was not included in the survey. During the 2011 Japan tsunami, a series of waves caused significant damage to floating docks within Noyo Basin (Wilson et al. 2013). The ends of Docks B and C were torn from the pile guides. Since that event, the destroyed section of Dock B has been replaced, the end of Dock C has not.

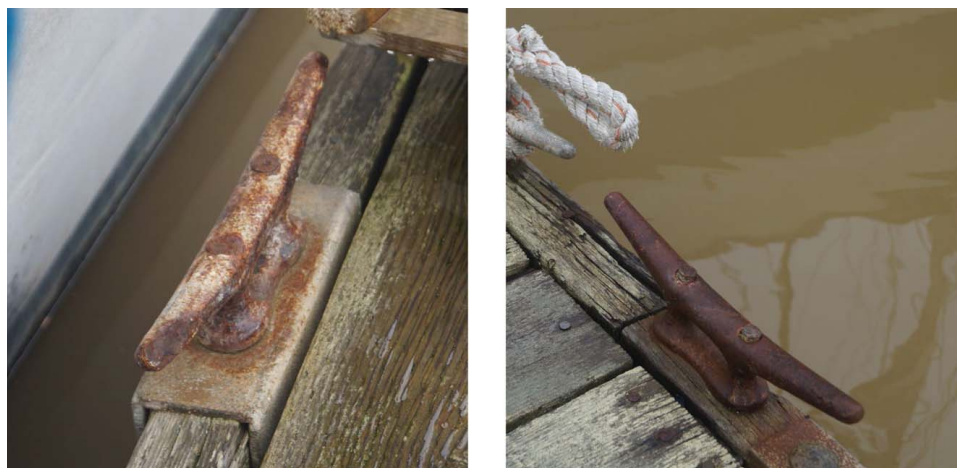
Fig. 8. Representative cleats from Noyo Basin. (Images by Adam S. Keen.)

A survey of Noyo Basin was conducted on March 10th, 2016. With 256 slips, we were able to photograph every slip and pile guide in the harbor. Representative cleats and pile guides from the survey are shown in Figs. 8 and 9, respectively. Frequent precipitation in Noyo River has caused the cleats and pile guides to corrode at a rate faster than average. With limited funds available to the facilities manager, the harbor is unable to keep up with the corrosion, which leaves it vulnerable to tsunami events.

The corrosion of the cleats and pile guides results in a severe reduction of the original capacities. Cleats were measured to be 250 mm (10-in.) during the field survey. M16 (1/2-in.) bolts are commonly associated with a 250-mm cleat (Sea-Dog Corporation 2018). The tension capacity of an M16 bolt (Grade 8.8) is 70.3 kN (British Standards 2005), which places the total new capacity of the cleat at 140.3 kN. An assessment of the cleat conditions based upon Table 1 and Fig. 8 places the cleat in the SD

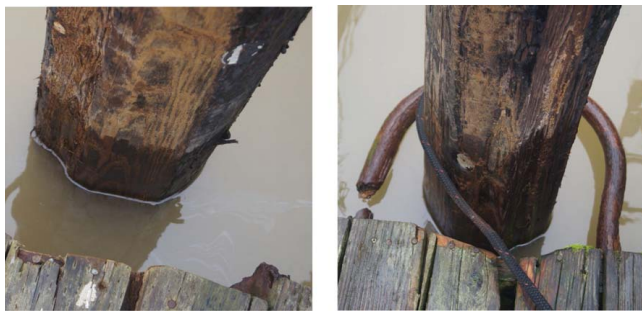
Fig. 9. Representative pile guides from Noyo Basin. (Images by Adam S. Keen.)

The hoop-type pile guides were observed to be in a similar state with major corrosion, with fractional or missing section loss common across most of the hoop-type pile guides. The pile guides' proximity and exposure to the water further accelerates the aging process. Four M16 (1/2-in.) bolts are commonly associated with pile guides in Noyo River. The tension capacity of an M16 bolt (Grade 8.8) places the total capacity of the pile guide at 280.6 kN. An assessment of the pile guide conditions based upon Table 2 and Fig. 9 places the pile guide in the SD class (Damage Class 5) range with section loss present in many of the pile guide
