Hurricane Michael in the Area of Mexico Beach, Florida

Abstract: Category 5 Hurricane Michael made landfall near Mexico Beach, Florida on October 9, 2018, with measured high water marks (HWMs) reaching 7.2 m NAVD88. The town itself received great damage, with many areas destroyed down to the foundations. In this study, we document the storm and its effects on the greater Mexico Beach area: hazard, structural damage, and their relationships. Wave and surge damage was nearly total for low-lying properties, but damage decreased greatly with increasing elevation. Major wave and surge damage was noted in Federal Emergency Management Agency (FEMA) X zones, which are out of the 100-year floodplain, and it is suggested that the 100-year storm is a deficient measure for categorizing flood risk. DOI: 10.1061/(ASCE)WW.1943-5460.0000590. This work is made available under the terms of the Creative Commons Attribution 4.0 International license, <https://creativecommons.org/licenses/by/4.0/>.

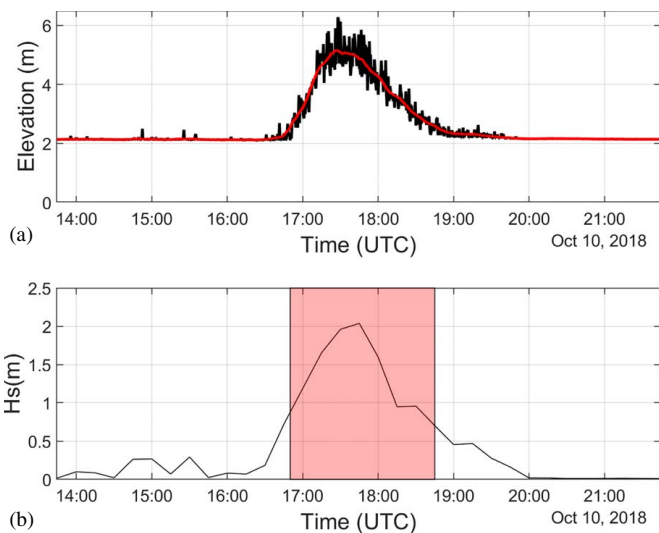
Fig. 2. (Color) Time series of water surface elevation (m) (NAVD88) from USGS gauge FLBAY03283 at the Mexico Beach Pier: (a) (—) unfiltered water level taken every 30 s; (—) moving 15 min average water level; and (b) significant wave height at pier. The shaded area represents the approximate time when the gauge did not go dry in wave troughs. Location is shown in Fig. 3.

Waves and surge began to rise consistently above the gauge elevation of 2.12 m North American Vertical Datum of 1988 (NAVD88), which is within 2 cm of the mean tide level in this area just before 17:00 UTC (12:00 local), reaching a surge peak of 5.16 m NAVD88, and a maximum instantaneous wave crest

elevation of 6.28 m (using the hydrostatic assumption) just before 17:30. These peaks were very short-lived, and by 19:00 only a few small wave crests were high enough to even reach the gauge. Realistically, most wave and surge damage probably occurred in the 1.5 h period between 17:00 and 18:30 UTC (12:00–13:30 local). This maximum wave crest of 6.28 m (20.6 ft) NAVD88 occurred in a National Flood Insurance Program (NFIP) 4.27 m (14 ft) VE zone (highest risk in the 100-year floodplain). No location in Mexico Beach (other than the pier in the ocean) had higher design elevations than this, while many inundated areas had much lower design elevations, and could be in the lower risk AE zones (moderate wave action in 100 year floodplain) or in Zone X (500 year floodplain) or Zone X (500-year floodplain) as shown in Fig. 3. Therefore, the conditions during Michael at Mexico Beach significantly exceeded design conditions for the 100-year flood plain.

Because water levels were only measured at 30 s intervals, no frequency information can be obtained about wave properties, but it is still possible to use the hydrostatic assumption to estimate time series of wave height at the pier. This is shown in Fig. 2(b), and was computed using $H_s = 4\sigma_w$ (Dean and Dalrymple 1991; Kennedy et al. 2011) where σ_w = the standard deviation of water surface elevation over a 15 min period, after subtracting the filtered surge time series. Heights reached a maximum of just over $H_s \approx 2$ m very near to the time of peak surge when mean water depths were probably > 3 m above ground elevation (we do not know the ground elevation during the storm so it is not possible to say with certainty), therefore, these were highly nonlinear waves capable of causing great damage to structures and

infrastructure. At times when the wave troughs could be lower than the gauge elevation, wave height values are lower bounds and Fig. 2(b) demarks these approximate times.

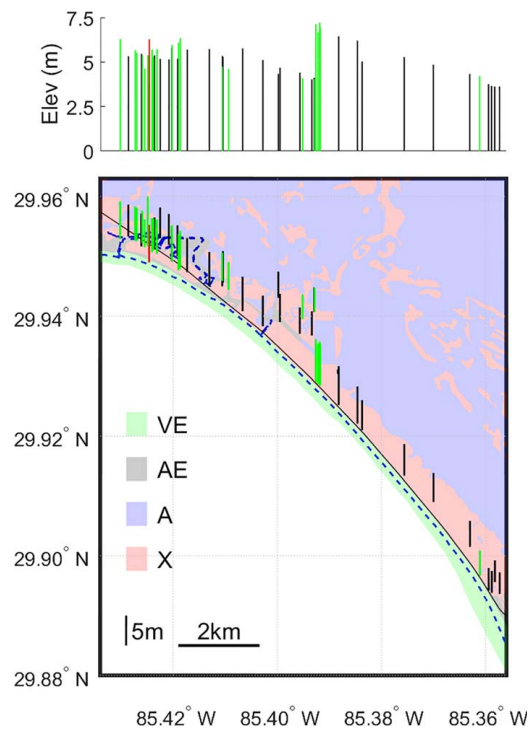
Fig. 3. (Color) HWMs in the vicinity of Mexico Beach: green represents measurements; black represents USGS; and red represents peak elevation from USGS sensor at pier. FEMA flood zones are as shown in the legend. Highway US98 is the solid black line close to the coast, and the NOAA shoreline is shown as a dashed line. Elevations are given in NAVD88 datum.

The HWM elevations shown in Fig. 3 demonstrates both their changes in space and overall consistency. In the northwestern area of Mexico Beach, flow depths were large from the beach to US98, with many measurements of 5–6 m NAVD88. All of these HWMs were identified on surviving structures; no HWMs were found anywhere near the original shoreline, where waves were almost certainly larger. Moving southeast along the coastline, HWMs become significantly lower at around 85.4°W, at approximately 4–5 m NAVD88. This is probably because measurements here were quite far inland. However, HWM elevations increase strongly at approximately 85.393°W, where the beach is very narrow, and there are high ground elevations just across US98. Runup here exceeded 7 m in several locations as evidenced by undisturbed runup debris, with a maximum measured elevation of 7.2 m NAVD88 [Fig. 3(b)]. Moving further southeast along the coast, HWM elevations decreased almost monotonically, with all HWMs east of

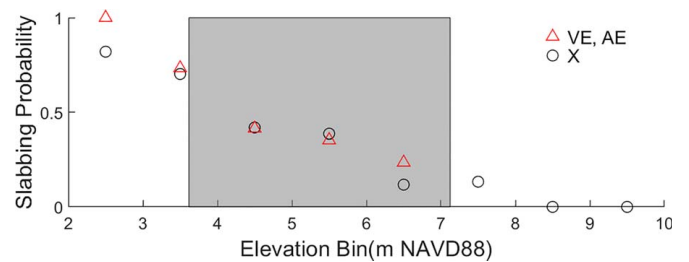
The immediate survival or destruction of a structure is an important safety consideration. In this study, destruction is defined by damage category DS6, where the structure is slabbed; that is to say, it is completely removed from its foundations. Fig. 12 shows the probability of slabbing during Michael for aggregated VE–AE zones and X zones. Unsurprisingly, the probability of survival increases strongly

Fig. 12. (Color) Slabbing probabilities as a function of elevation over the Mexico Beach region for combined VE and AE zones (triangle); X zone (circle). The shaded region shows the range of observed HWMs.

with increasing building elevation. Somewhat surprisingly, the probabilities for VE–AE and X zones are almost identical, indicating that structural elevation was the overwhelming factor for survival. Because there was a range of inundation over the Mexico Beach region, this is reflected in the slabbing probabilities. Because Michael so greatly exceeded the 100-year event, the near coast DFIRM zones behaved like one. We note that this study looks almost exclusively at structures in the first few hundred meters from the shore, and slabbing behavior would certainly be different further inland.

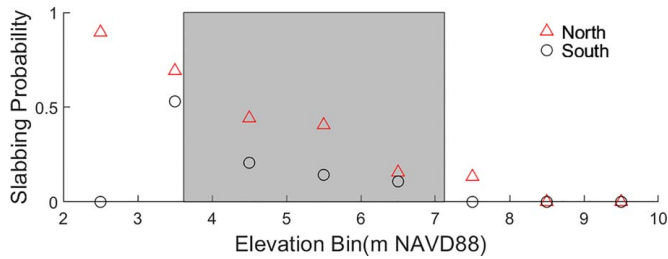
Fig. 13. (Color) Slabbing probabilities for all flood zones combined as a function of location. North Mexico Beach (triangle); South Mexico Beach (circle). The shaded region shows the range of observed high watermarks.

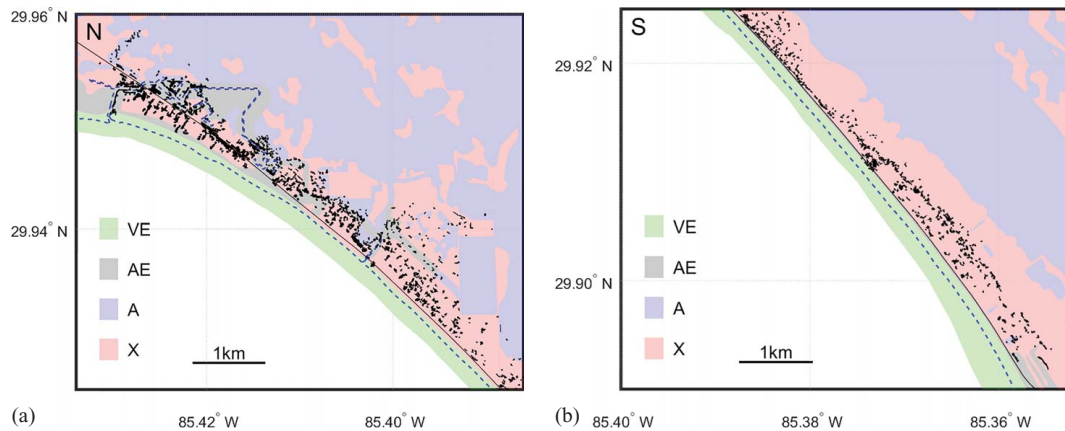
Fig. 15. (Color) Debris clusters in (a) North Mexico Beach area; and (b) South Mexico Beach area.

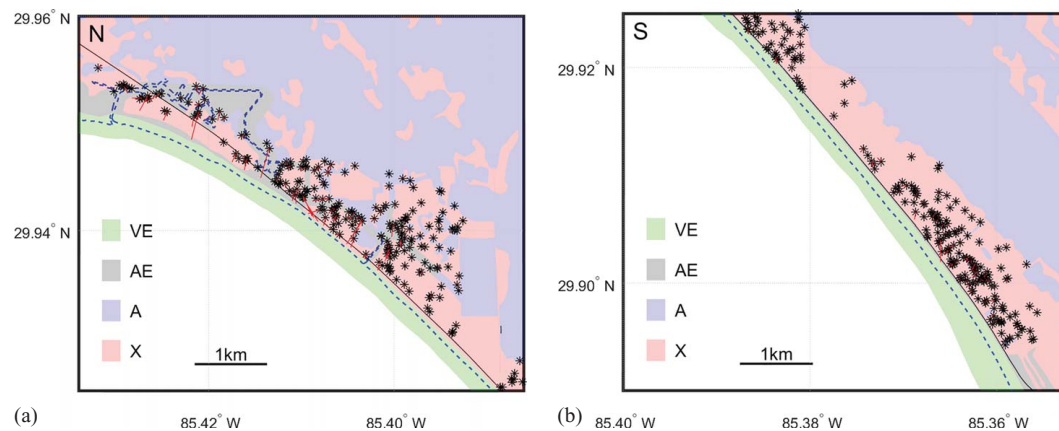
Fig. 16. (Color) Resting places for distinct LDOs identified in Mexico Beach post Michael: (a) North Mexico Beach; and (b) South Mexico Beach. Red lines indicate transport paths from original locations, where identified.

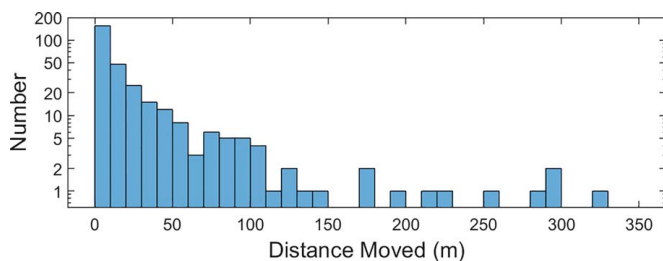
Fig. 17. (Color) Distance moved for LDOs in cases where original locations could be determined.
